# B4U Close Home Inspections Report

123 Your Street  
Georgetown, KY

Prepared for  
Bill & Dale Client

B4U Close Home Inspections Photo Album  
123 Your Street, Georgetown, KY

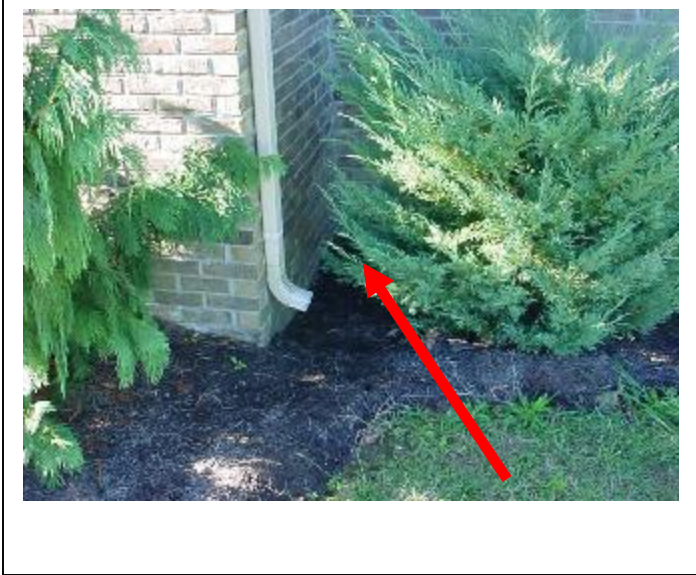
Add leader to this downspout and soil to the corner to allow the water to drain away from the structure.

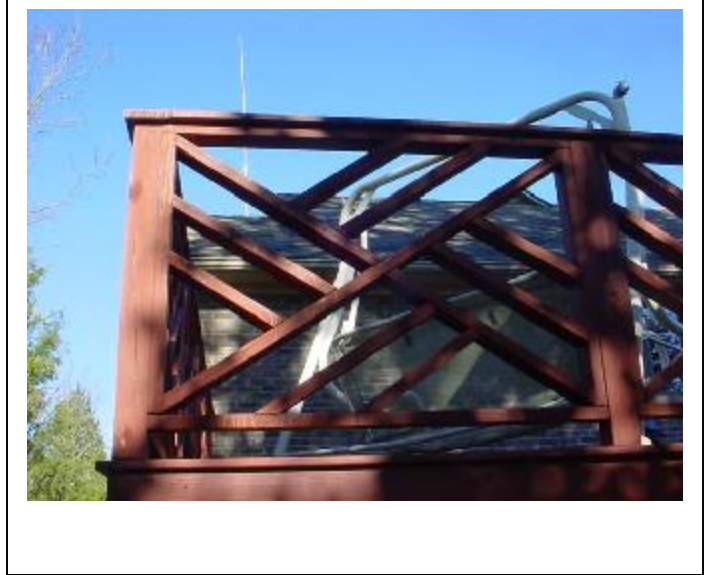
This deck rail creates a climbable ladder effect.

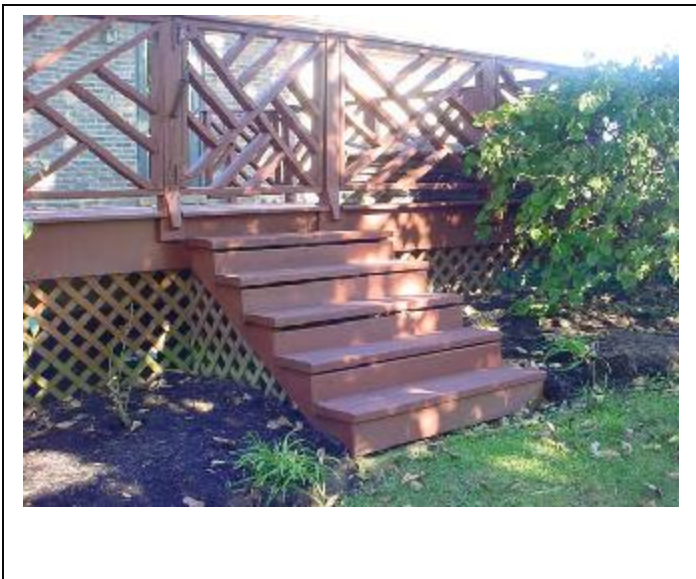
The deck steps should have a grippable handrail installed for safety.

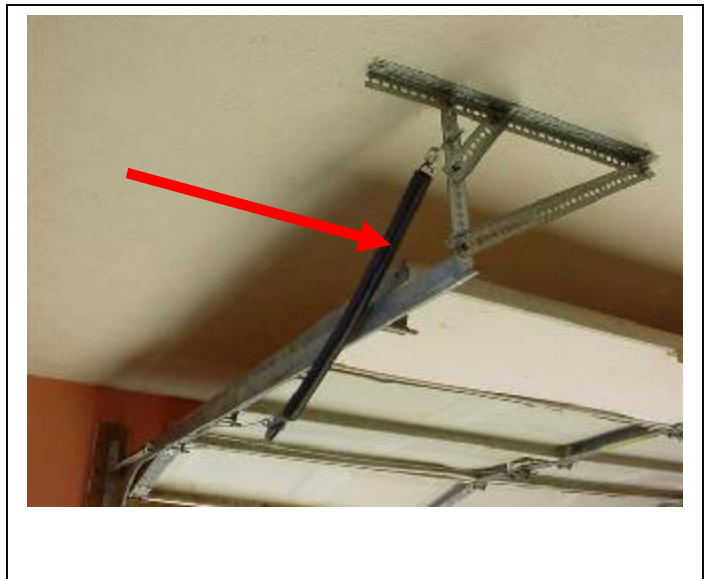
The overhead door springs should have a safety cable ran thru them in case they break.

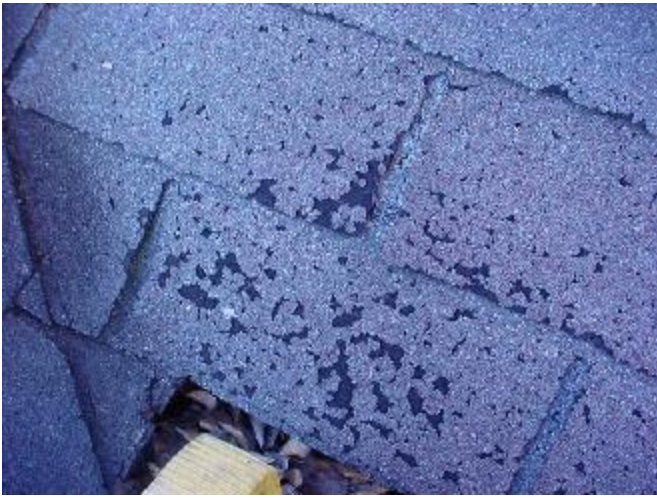
The deterioration shown here signals that the shingles are nearing the end of their design life.

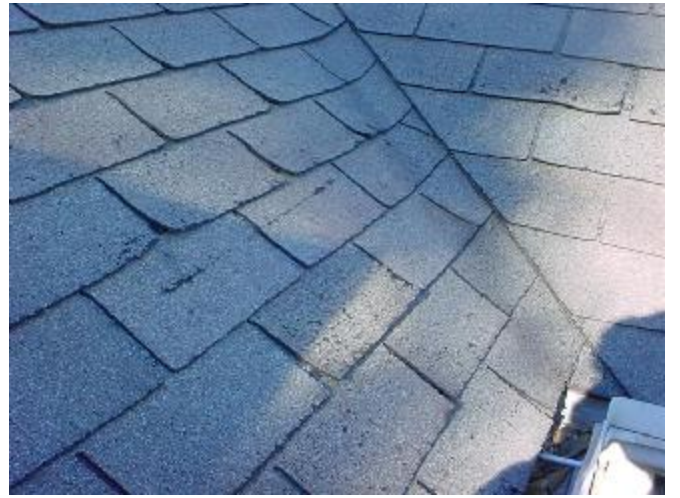
The cupping and curling shown here are signals that the shingles are nearing the end of their design life.

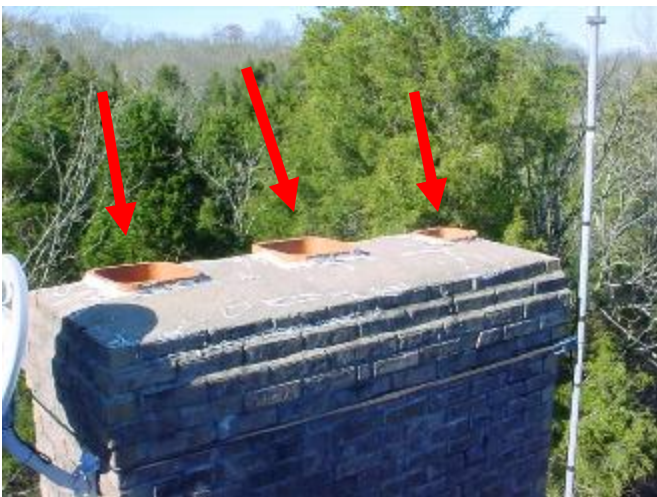
I recommend installation of rain caps on these chimney flues to prevent water getting into the fireplaces.

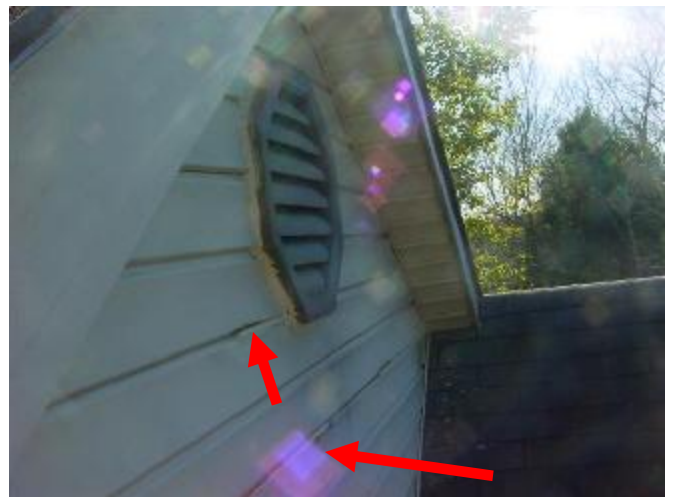
I don't know why the caulking was placed on the vinyl siding joints. Ask the seller.

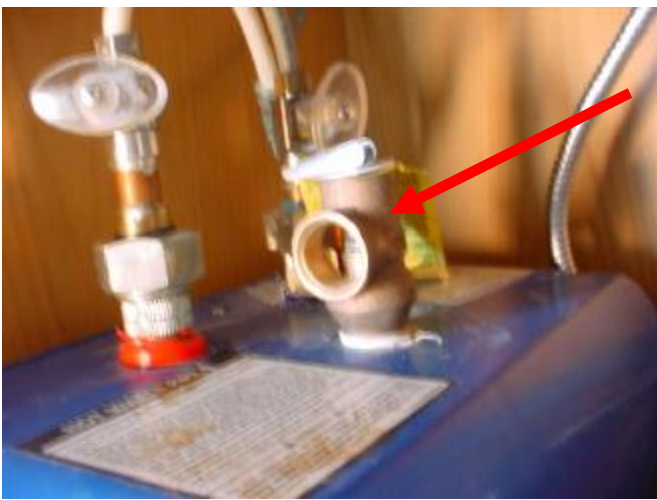
TPRV on water heater under kitchen sink needs a drain pipe installed to direct any discharge safely away from people. Review installation instructions.

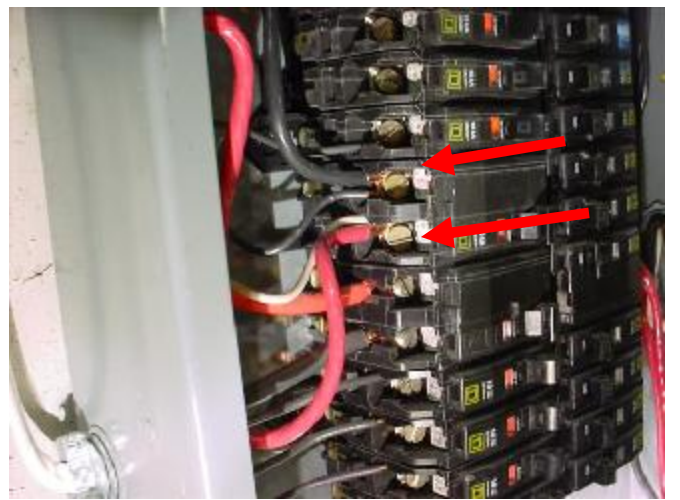
Breakers are not generally designed for two wires under the same screw. Especially with different wire sizes. Others exist beside these two.

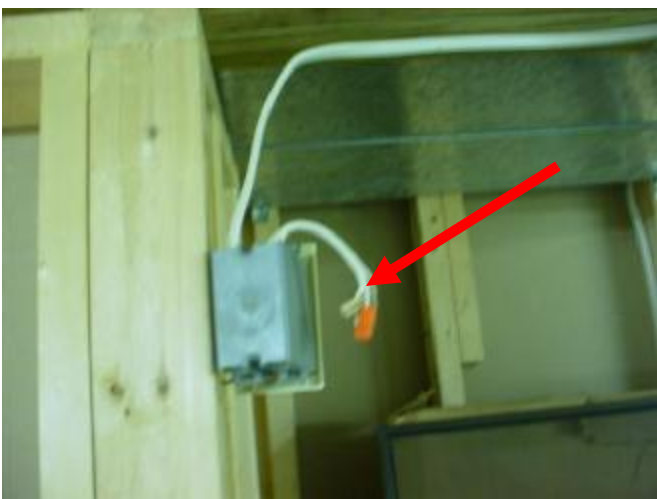
Terminate these electrical wires correctly.

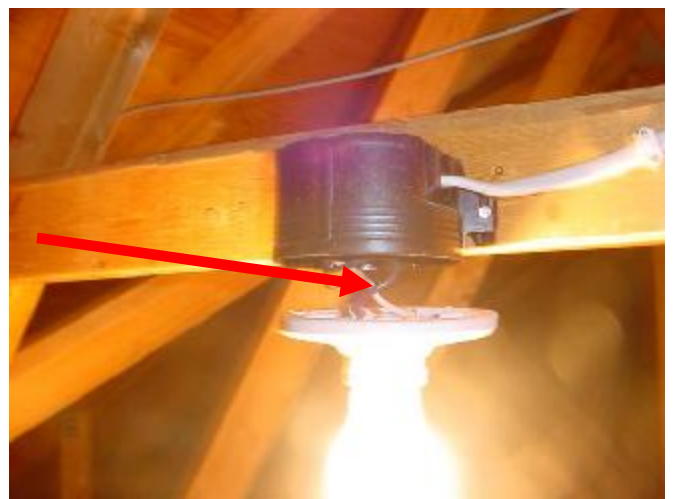
Light fixture in attic supported only by wires.

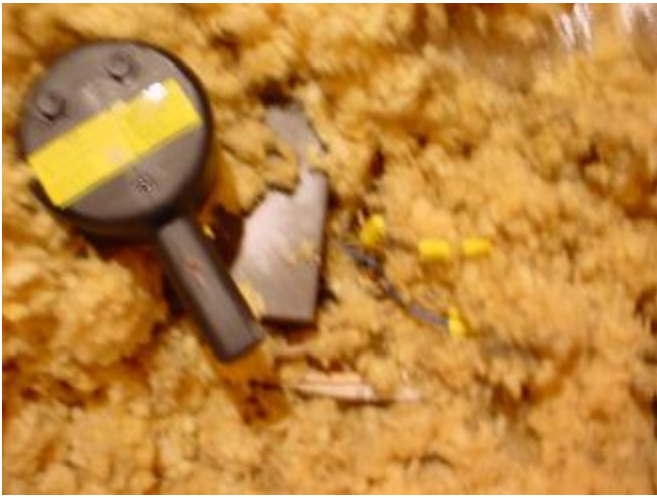
Unsafe electrical splice in attic at bathroom vent fans. Splice should be in covered junction box.

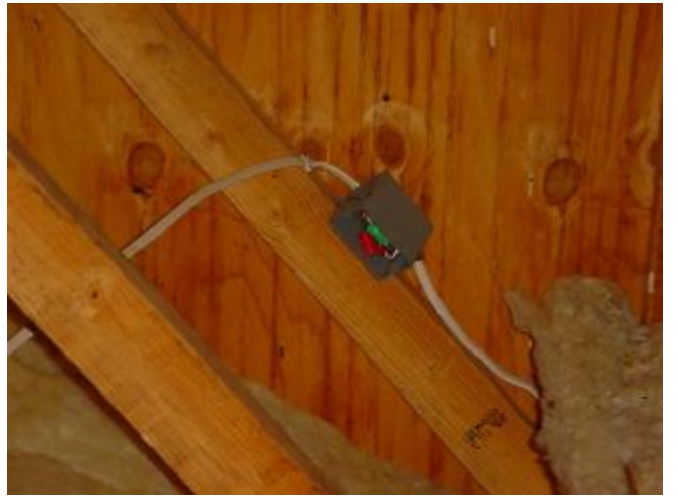
Uncovered junction box at rear wall of gable over dining room.

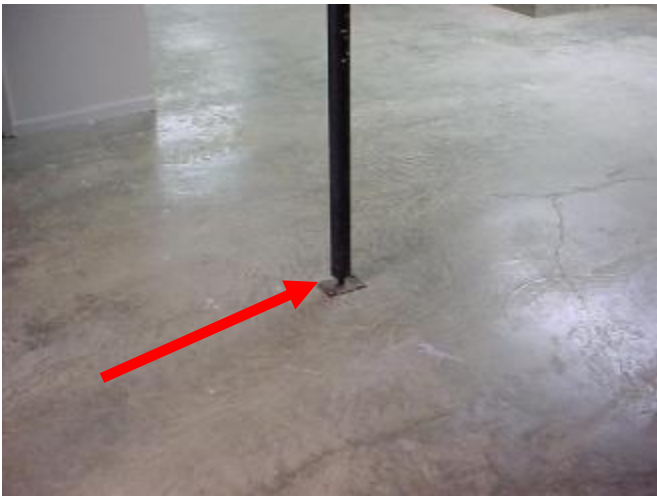
See notes under Structure – Piers/Posts about these steel columns.

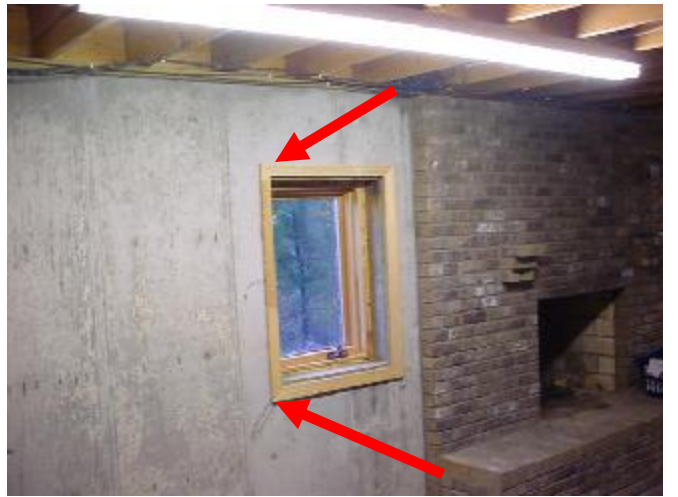
Typical cracks at top & bottom of left side basement window.
