B4U Close Home Inspections Report

123 Your Street
Georgetown, KY

Prepared for
Bill & Dale Client

B4U Close Home Inspections Photo Album
123 Your Street, Georgetown, KY

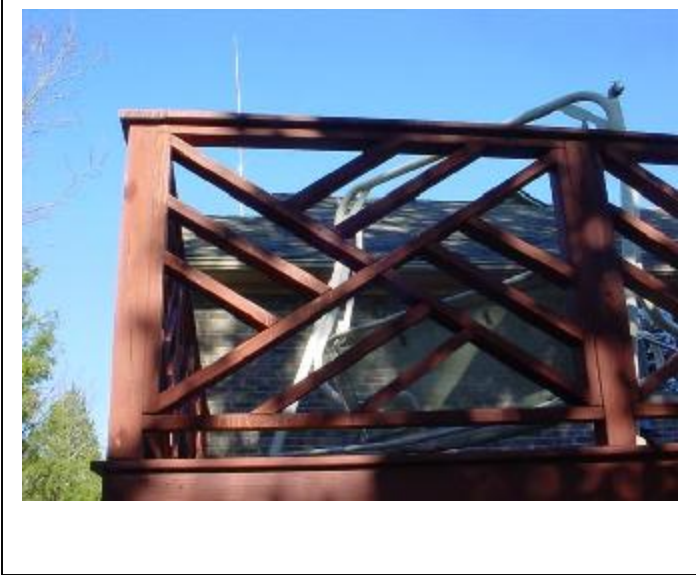
This deck rail creates a climbable ladder effect.

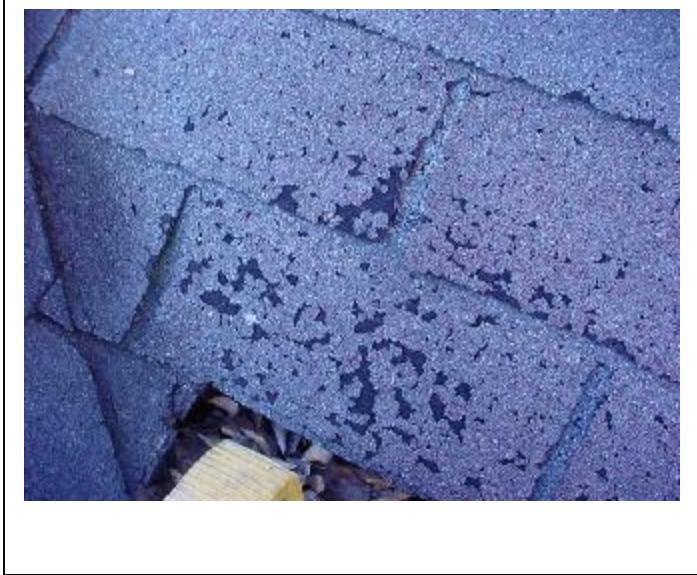
The deterioration shown here signals that the shingles are nearing the end of their design life.

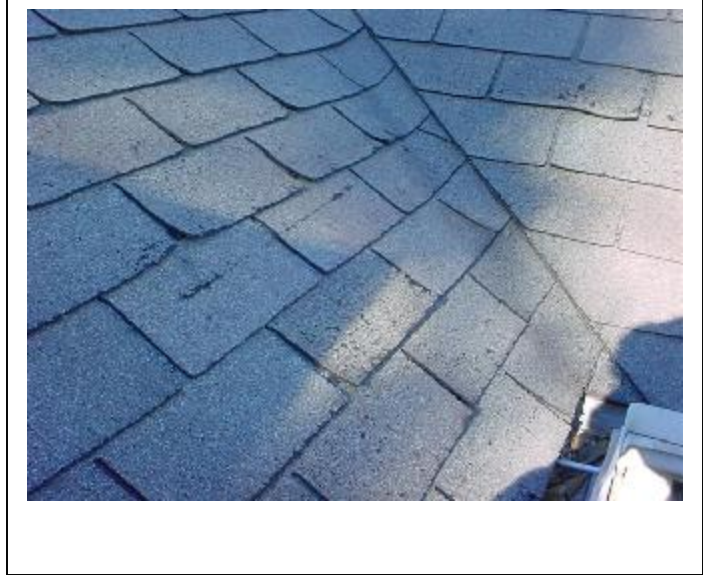
The cupping and curling shown here are signals that the shingles are nearing the end of their design life.

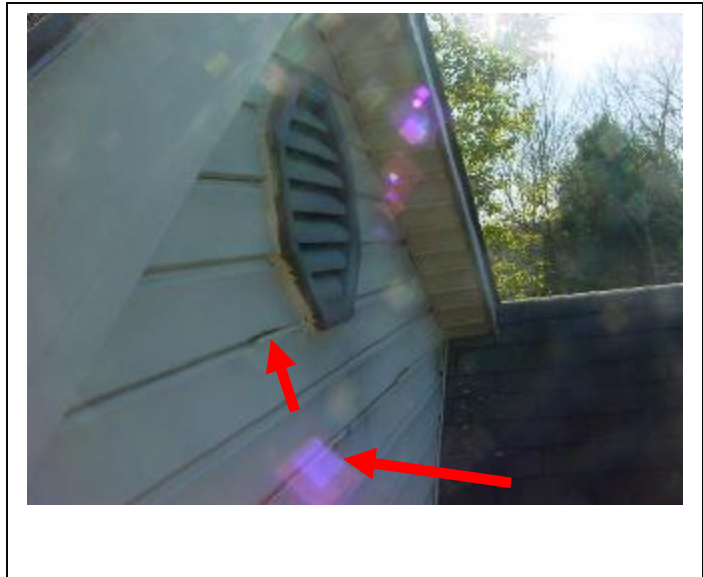
I don't know why the caulking was placed on the vinyl siding joints. Ask the seller.

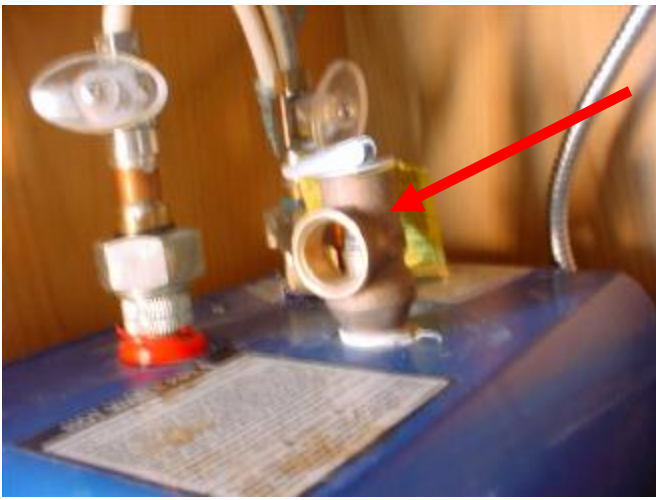
TPRV on water heater under kitchen sink needs a drain pipe installed to direct any discharge safely away from people. Review installation instructions.

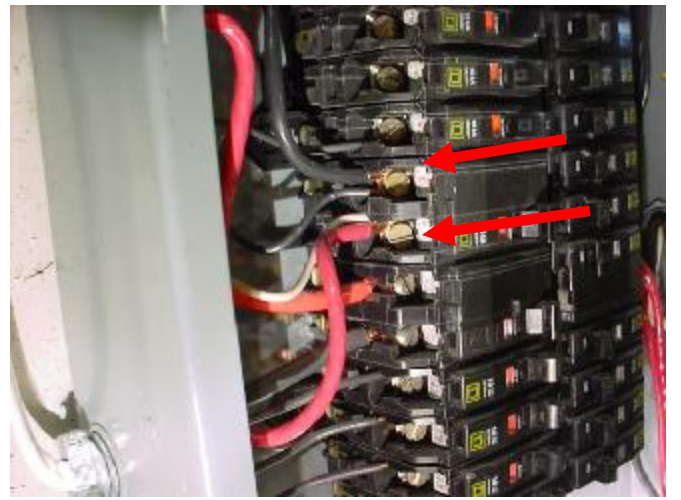
Breakers are not generally designed for two wires under the same screw. Especially with different wire sizes. Others exist beside these two.

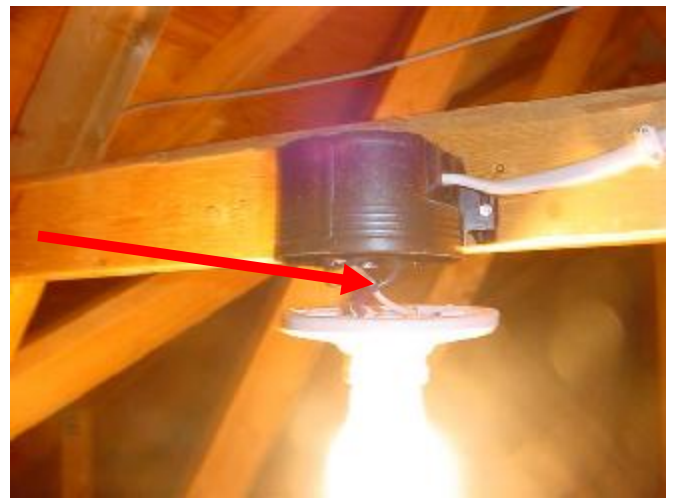
Light fixture in attic supported only by wires.
