B4U Close Home Inspections Report

123 Your Street
Any Town, KY

Prepared for
Hill & Dale Client

B4U Close Home Inspections Report Photo Album
123 Your Street, Any Town, KY

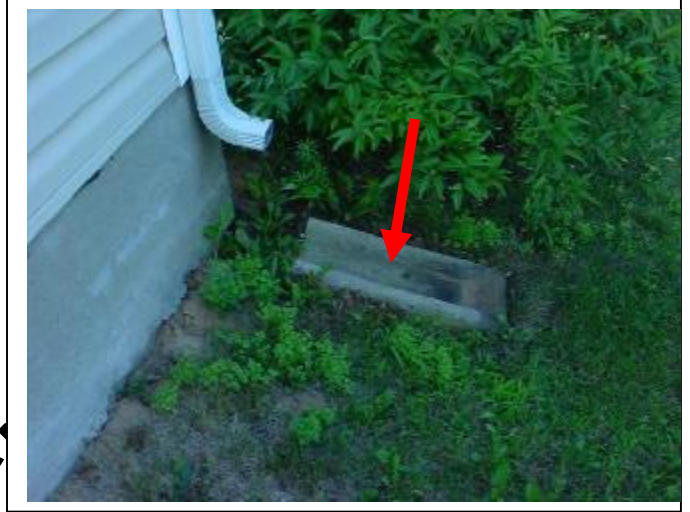
Splash blocks are installed backward.

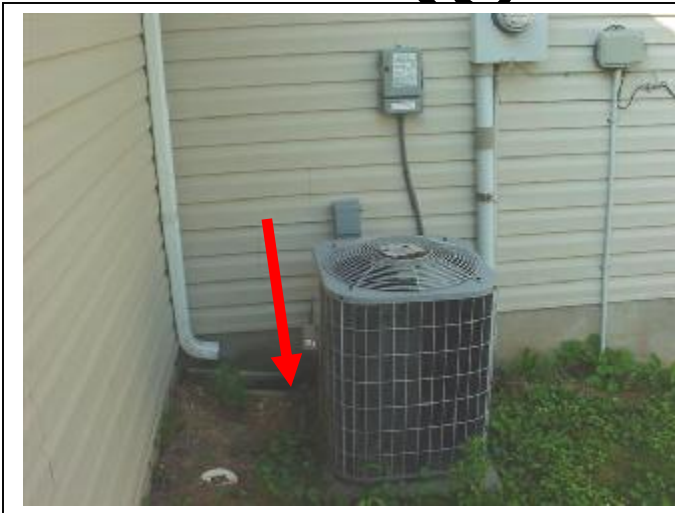
Holes next to foundation need to be filled in.
Splash block needs to be turned around.

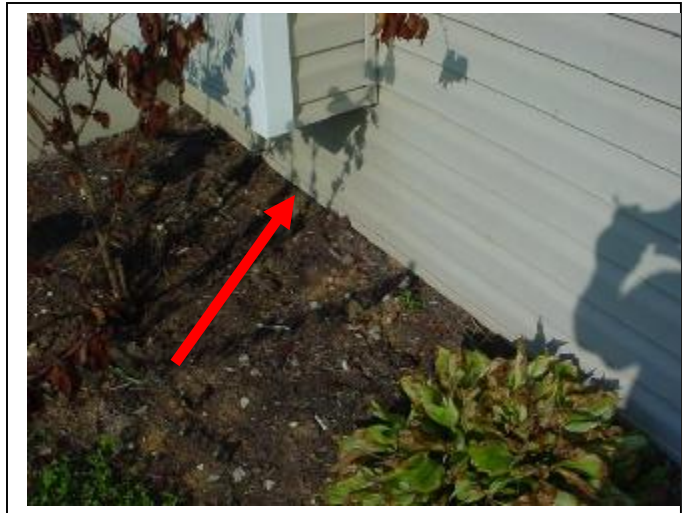
Soil/mulch too close to the siding. Lower the soil/mulch level.

Grading: Minor slope - Siding in contact with soil on right side. May promote rot or allow termite access.

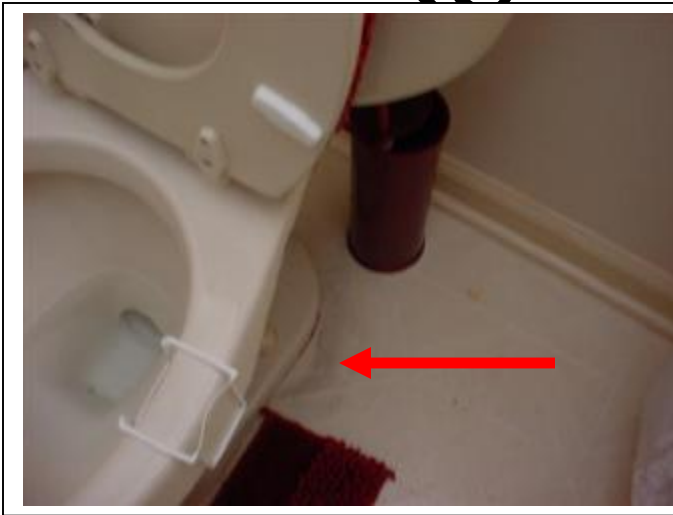
Purple stains indicate leaking under the toilet in the master bathroom.

Master Bathroom - Toilets: Porcelain - The toilet is loose and slides around on the floor. The purple stain indicates that the toilet is leaking under the vinyl. It needs to be tightened down to prevent wear and tear on the wax ring seal and potential leaking. Care needs to be exercised when tightening toilets. One little bit to much force on the nuts and the toilet will crack necessitating a new toilet.

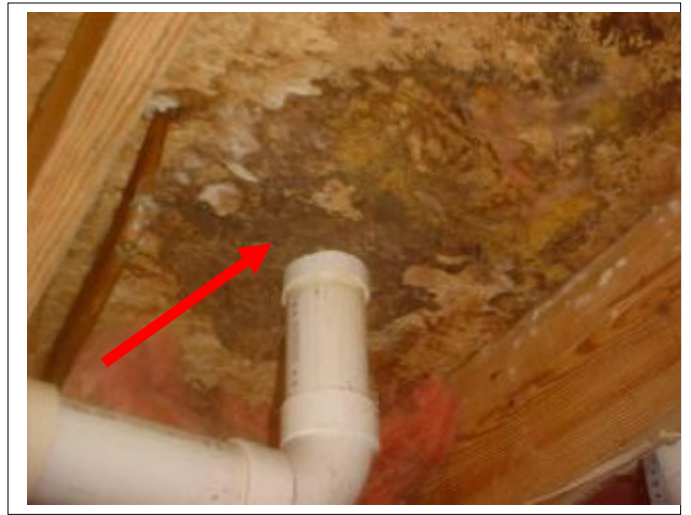
Wood under toilet in master bathroom is moisture stained but does not appear to be damaged enough to replace it. Examine wood under toilet while replacing wax ring.

Acceptable **Structure Type:** Wood frame with vinyl siding
Acceptable **Foundation:** Poured Slab
Acceptable **Differential Movement:** None noted.
Acceptable **Floor/Slab:** Where visible - Majority hidden by finish materials.
Acceptable **Subfloor:** OSB - Oriented Strand Board - Sub floor under master bathroom toilet is moisture stained but does not appear to be damaged enough to call for replacement. Examine the top of the wood when the toilet is removed to replace the wax ring.
